MANAGING A MAJOR LUBE OIL LEAK ON A 150 MW STEAM TURBINE POWER PLANT

PT DSSP Power Sumsel, South Sumatera, Indonesia^{1,2}

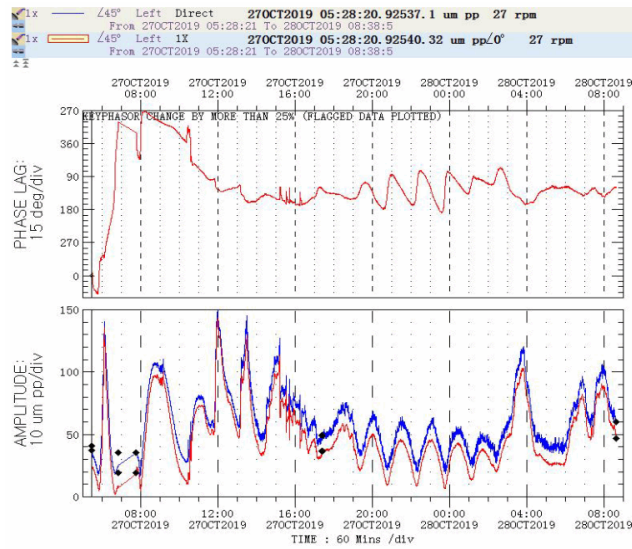
Figure 2. Vibration trend

The turbine was restarted on October 27th, 2019, with the rolling process eventually stabilizing at the rated speed of 3000 rpm, albeit displaying characteristic forced vibration during speed rises, indicating the presence of internal friction points within the casing. However, through the running-in process, accompanied by casing warming and expansion, the internal friction points gradually diminished, leading to decreased and stabilized vibrations. Fig. 2 shown the whole rolling process was as follows (speed-trend diagram, taking 1x as example).

Despite the high vibration of all bearings remaining within acceptable range values, the lube oil leak persisted from bearing box No. 2. This underscored the importance of addressing the underlying issues causing the leakage, even in the presence of acceptable vibration levels across other bearings.

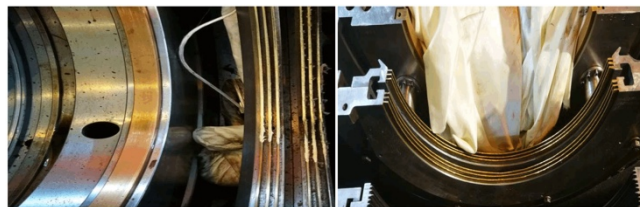
Figure 3. Oil deflector replacement and clearance adjustment

After the turbine overhaul process was carried out in 2019, wear was discovered on the oil deflector labyrinth seals of bearing No. 1 and No. 2, induced oil leaks. The solution involved replacing the oil deflector with a new spare part and adjusting the radial clearance according to the design specifications, as depicted in Figure 3.

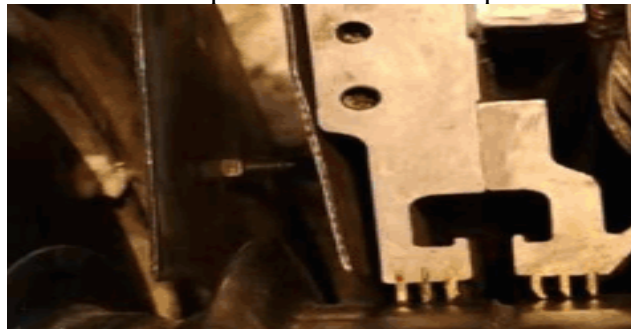
Figure 4. Wearing at blocking teeth (labyrinth) of the oil seal

During the Class A Turbine Overhaul conducted in August - September 2023, the inspection of oil sealing wear and clearance was repeated. It was discovered that there was wear on the blocking teeth (labyrinth) of the oil seal, as depicted in Fig. 4. Additionally, the clearance on the bottom oil sealing was found to be excessively large, measuring approximately 0.3 mm, whereas the design requirement specifies a clearance of 0.05 mm - 0.10 mm. To address this issue, repairs were undertaken by reinstalling the oil sealing in accordance with the specified clearance requirements.

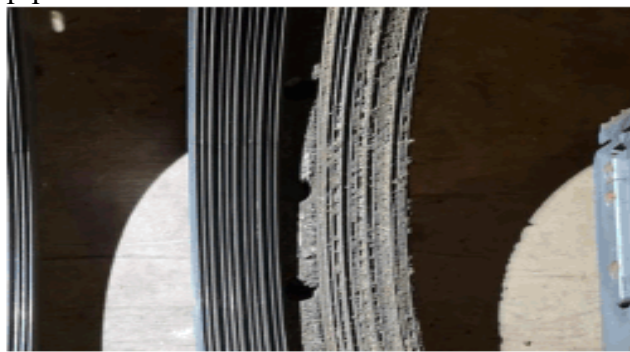
Figure 5. Oil sludge on the intermediate pressure rear shaft steam sealing ring

It was also discovered that the first row of rear shaft steam sealing on the Intermediate Pressure Turbine side was covered with oil sludge, as depicted in Fig. 5. Additionally, an inspection of the oil return pipeline was conducted, revealing no defects or blockages in the pipeline.

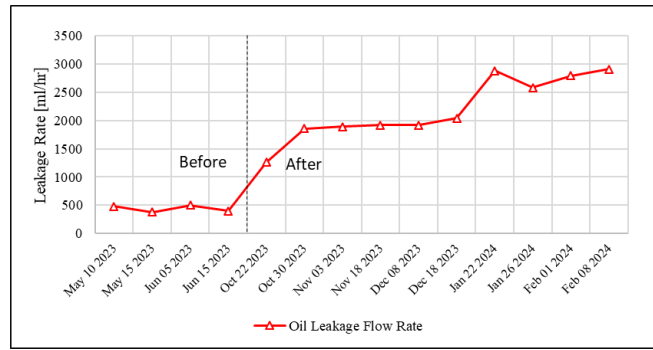
Figure 6. Increment of oil leakage rate

The monitoring results of the oil leakage rate after the overhaul are illustrated in Fig. 6. It is evident that there has been a notable increase in the oil leakage rate. This escalation may have been caused by improper gasket installation, leading to heightened vibration during startup and exacerbating the oil leakage issue. In order to reduce the vibration to within acceptable range values, adjustments were made by uninstalling the gasket. Consequently, the vibration issues were resolved, but the oil leakage rate from bearing box No. 2 increased, reaching 2800 ml/h at a full load of 174 MW.

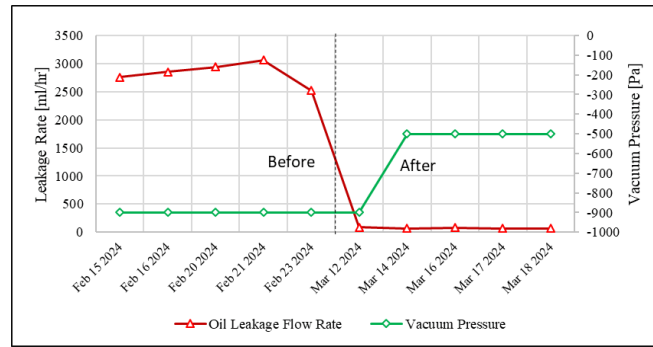
Figure 10. Decrement of oil leakage rate

The implementation of various rectification measures to address the lube oil leakage issue from bearing box No. 2 has yielded commendable results, leading to a significant reduction in the oil leakage rate. As shown in Fig. 10, during full load operation, the average oil leakage flow rate has decreased substantially from approximately 2826 ml/hr, equivalent to 67-68 litres per day, to a mere 75 ml/hr, equivalent to 1.5-2 litres per day. This remarkable reduction represents a decrement of around 97.3%, indicating the effectiveness of the rectification efforts in mitigating the oil leakage problem.
