CAUSE ANALYSIS AND IMPROVEMENT MEASURES FOR SUPERHEATED PLATEN TUBES FAILURE OF A 580 t/h CFB BOILER

Chelsi¹, Msy Cahaya Dinda Pamungkas²

PT DSSP Power Sumsel, South Sumatera, Indonesia^{1,2}

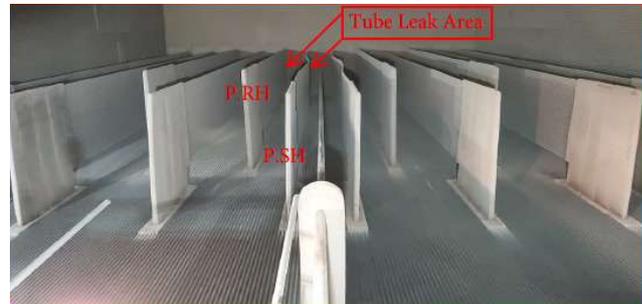
Figure 1. The location of the tube failure

superheater tube is comprehensively investigated with guidance of previous research and literature study. The research is based on events of tube failure that occurred in 2017-2021. Consequently, plant downtime in July 2021 almost 2 weeks for recovery. The location of tube failures in platen superheater at 2x150 MW coal fired power plant shown in figure 1.

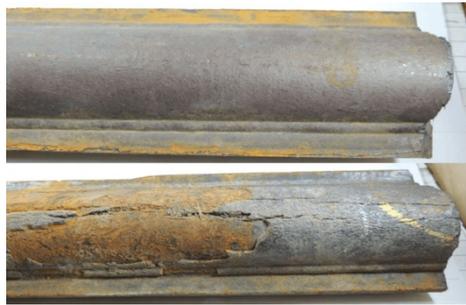
Figure 2. Exterior straight tube condition

The sample of Platen Superheater (PSH) tube divided into straight and elbow tube. The exterior of the straight PSH tube is visually examined and the result shown in Figure 2. The exterior has two different conditions which are damaged side and no-damaged side. The no-damaged side show uniform condition where there is no removed material and no change in color. Meanwhile, the damaged side show the non-uniform condition where removed material is observed and also corroded surface shown as area with red-brown color. There are also cracks observed on the surface of the tube which are suspected as cracks on the oxide layers of the tube since it is shown as a removed layer from the tube surface instead of the through wall crack.

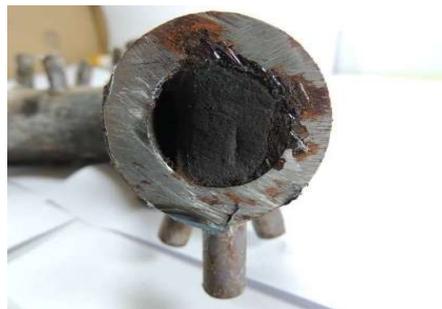
Figure 3. Elbow tube condition

The condition of the elbow tube is as shown in Figure 3. It can be seen that the black deposits forming a texture similar to sludge that sticks on the inner diameter surface of the elbow tube.

Magnetite and hematite are the product of iron oxidation. The silica is the chemical formula of sand and pyrite is the mineral usually found in coal. Considering the pyrite as the product of Hydrogen Sulfate (H_2S) corrosion is irrelevant to the operating condition of the boiler. Since the tube flows saturated steam with temperature more than $400\text{ }^{\circ}C$ and there is no change for microorganism to survive under this very high temperature. Therefore, it is make sense that the presence of deposits must have been coming from the outside of the tube and somehow it enters the tube and then plug the tube.

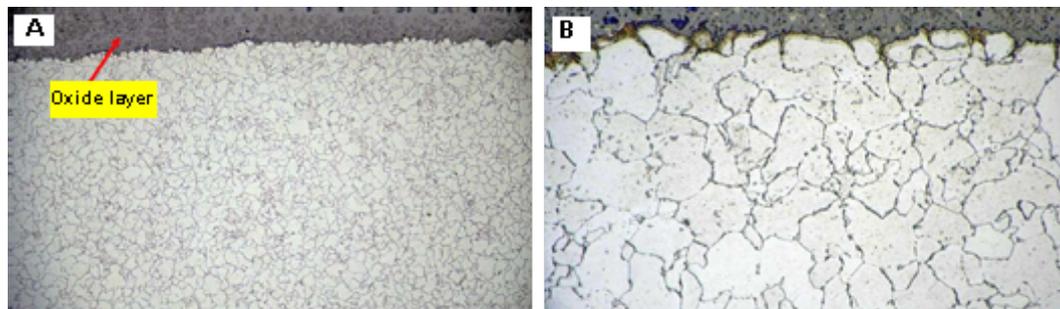
Figure 4. The microstructure of exterior side PSH tube on no damaged area under magnification of (A) 200X and (B) 1000X

The microstructure of PSH tube at no damaged area is observed on the exterior and interior side of the tube cross-section as shown in Fig. 4 and Fig. 5. On the exterior side, thick layer of nonmetallic material is identified since it is not affected by etching chemical. This layer is oxides that grow from the surface of the tube due to oxidation. The oxide layer is observed on the exterior and interior side indicates that oxidation had occurred on the both tube side. The microstructure of PSH tube not show ferrite-pearlite structures as usually found in carbon steel. The pearlite has been degraded where it changed into dispersed particles in the ferrite matrix. This phenomenon is usually termed as spheroidization where the lamellar structure of pearlite is fragmented into rounded-shape particles in the ferrite matrix.

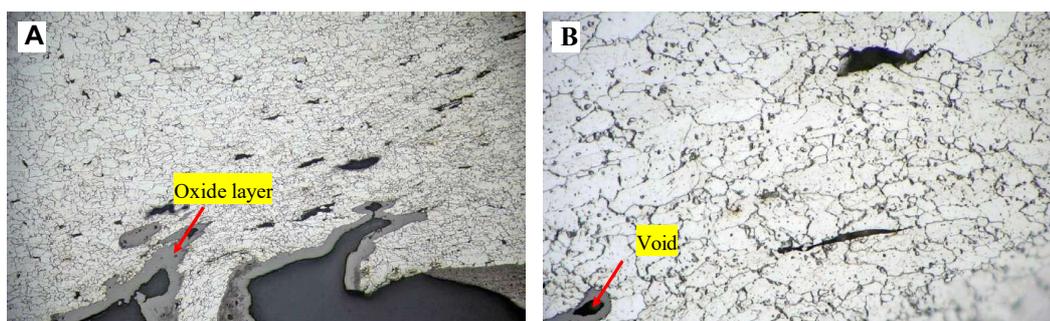
Figure 6. The microstructure of exterior side PSH tube on damaged area under magnification of (A) 200X and (B) 1000X

Observation of the microstructure of PSH tube is also made on the damaged area. The results are shown in Fig. 6 and Fig. 7 where the oxide layer is still visible on the exterior and interior side of the tube. The microstructure is similar with the no damaged area, another important fact at this damaged area is the visible voids within the matrix. The voids are formed on the grain boundaries of ferrite matrix indicates of creep phenomenon has occurred.

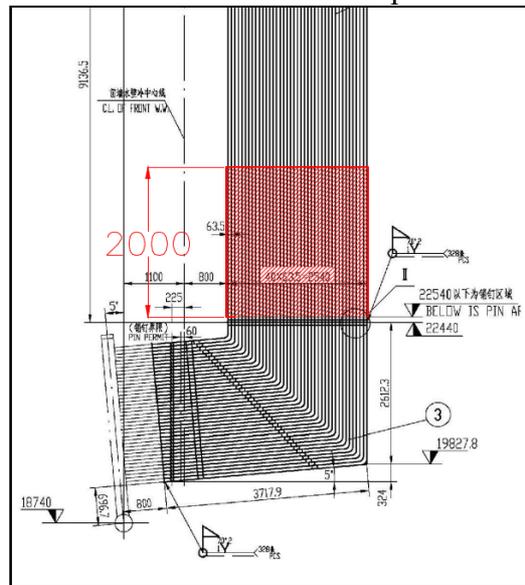
Figure 9. Additional refractory drawing

Based on the laboratory analysis mention before, the PSH tube failure caused by overheating due to high thermal exposure. It was observed that the refractory installed inside the furnace did not cover the PSH tube as per the design. Thus it became imperative to improve this condition by add refractory to cover the boiler tubes.

overheating induced failures. Therefore, the rectification involved installing additional refractory into PSH tube panel number 3, 4, 5, and 6 at an elevation of 22-28 meters, spanning 2 meters in total as shown by Fig.9.

This required the use of 40,960 stud pins to secure the refractory in place. The refractory used is refractory patch castable versa flow 70 plus with maximum service temperature 1705 °C and calcined base chemical composition.

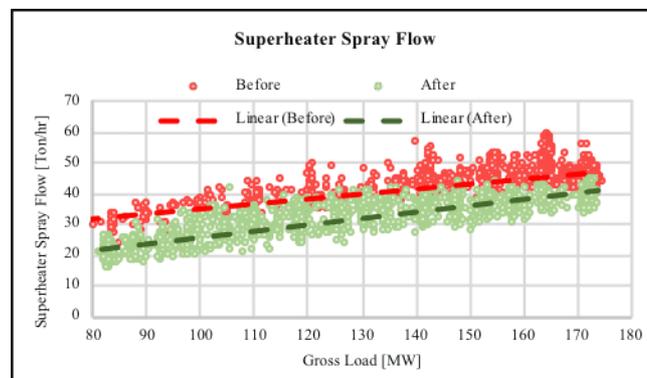
Figure 10. Superheater spray flow consumption monitoring result

Monitoring results show a reduction in the use of desuperheater flow reaching 6-10 tons/day at the same load after installation additional refractory, the actual record shown in Fig 10. Three sample tubes were observed to see its effect on tube temperature. Fig. 11 show temperature exceed alarm value before meanwhile Fig. 12 shows a decrease in tube temperature reaching 15-40 °C after installation of additional refractory.
