BLADE LIFT HYDRAULIC SYSTEM TROUBLESHOOTING ON KOMATSU D70-LE BULLDOZER (TROUBLESHOOTING SISTEM HIDROLIK BLADE LIFT PADA BULLDOZER KOMATSU D70-LE)

Denny Hendra Cipta^{1*}, Lisa binti Harun², Yosua Kombong Manglili³

^{2,3} Politeknik Negeri Nunukan (PNN), Indonesia

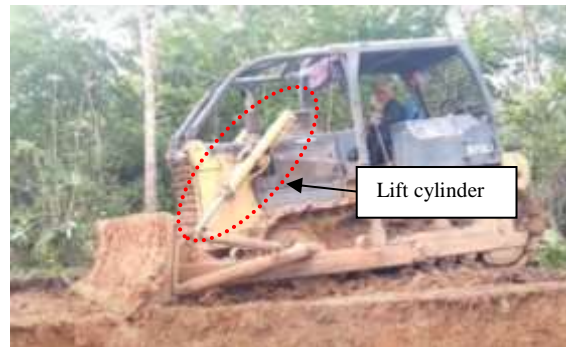
The preliminary testing was carried out to more precisely determine where the troubles in the Komatsu D70-LE bulldozer ocurred. Based on the report from the operator on duty, where there was a problem for him maintaining the bulldozer blade in floating position during the operation. The mechanic then checks and tests by operating the blade drive hydraulic system. The hydraulic control system functions properly, the actuator follows the input from the control levers. The problem appears when the control lever is left in the floating position, the blade will drop due to its own weight. This symptom shows that the lift cylinder cannot hold the blade position according to the command of the control lever. From the test result, it turned out that the problem was in the blade lift cylinder component. where the lift cylinder cannot maintain it's pressure, which resulted in the blade going down by itself (hydraulic drift). From the preliminary testing and the results of visual inspection it is concluded that the source of the trouble is in the blade lift cylinder. To correct this problem it is necessary to dismantle the blade lift hydraulic cylinder (Anhar & Faisal, 2021) (Simanjuntak & Novan, 2019)(Yang, Xiao, & Ze, 2014).

Figure 2. Blade lift hydraulic cylinder

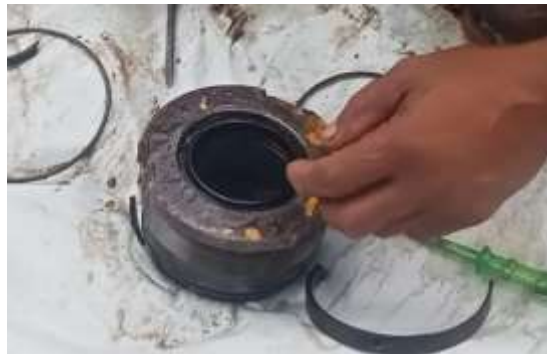
Disassembly aims to separate the components into smaller parts so as to facilitate the inspection stage. Disassembly must be done carefully so as not to cause new damage. Some components of the hydraulic cylinder are reusable and some are not which have to be replaced disregarding the condition of the hydraulic cylinder. Before removing the hydraulic cylinder, the system pressure must be relieved. The blade is rested on a solid base, the hydraulic fittings are released and the cylinder pins are removed. The hydraulic cylinder then removed from the blade and disassembled to reach the inner components of the hydraulic cylinder.

Figure 3. Dust seal removal

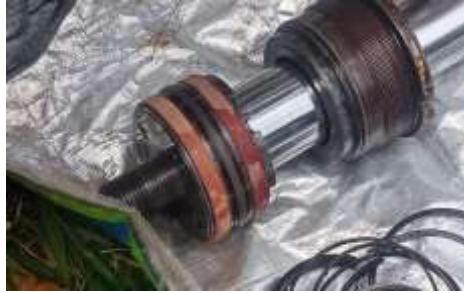
Figure 5. New wear seal on cylinder piston

Assembly is the process of assembling components into a ready-to-use form, returning to its initial form. After the hydraulic cylinder is assembled, it is then reinstalled on the bulldozer body and blade. The hydraulic hoses and fittings also reconnected. This process is done by following the manufacturer shop manual (Prabowo, 2008).
