IMPLEMENTATION OF ANTI-ABRASION GRID IN SUMSEL-5 580 t/h CFB BOILER (RELIABILITY AND PERFORMANCE EVALUATION)

Operation Department PT DSSP Power Sumsel, South Sumatera, Indonesia^{1,3}

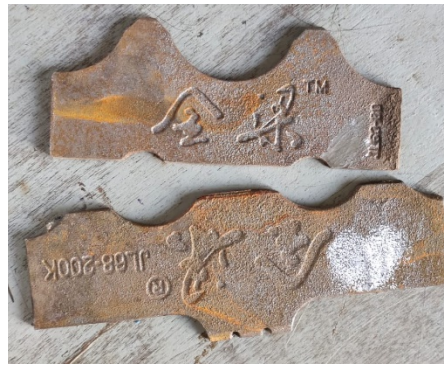
Figure 6. Horizontal and vertical anti-abrasion grid sample

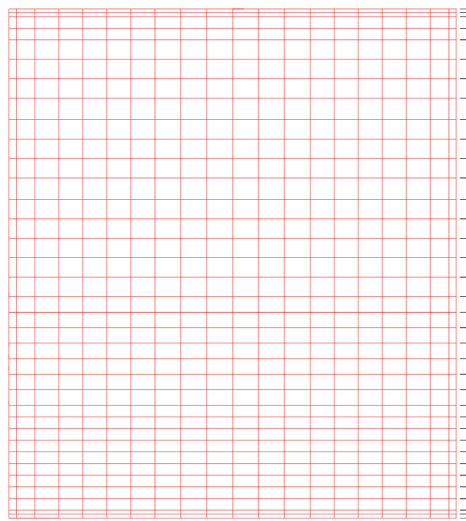
Figure 7. Schematic installation of anti-abrasion grid on front water wall

Anti-abrasion grid was installed at elevation of 14 m until 41 m, with the distance between horizontal grid of 0,2 m; 0,6 m; 0,8 m; and 1 m. The distance between vertical grid was set to 1,2 m. Anti-abrasion grid installation was perpendicular to water wall tubes. Anti-abrasion grid installation was done on 4 sides of water wall, including on front water wall, south side water wall, north side water wall, and rear water wall.

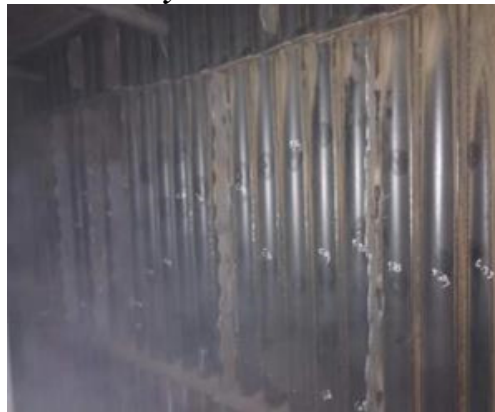
Figure 10. Installed grid in Sumsel-5

Anti-abrasion grid was installed during maintenance outage in 2022 and would be observed back in 2023 to see the effectiveness of the installation. During one year of full operation, no trip was occurred due to water wall tube leak. Visual check result also showed that no sign of significant abrasion was impacted on water wall tubes.
