RENOVATION OF JGC-30 COAL FEEDING BELT IN THERMAL POWER PLANT

Liu Yang[1], Muhammad As'ad Abidin[2]
PT. DSSP Power Kendari, Indonesia[1,2]
Email: liu.yang@dsspower.co.id[1], muhammad.asad@dsspower.co.id[2]

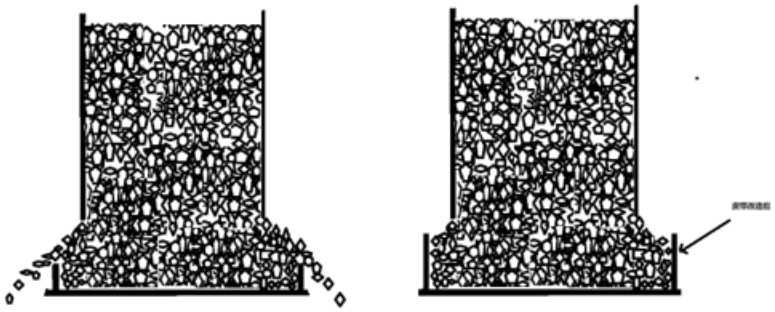
By modifying the coal feeder belt, before optimization (as shown in Figure 2-1), the raw coal in the raw coal hopper naturally falls to the upper part of the coal feeder belt through the coal outlet by its own weight. There is a gap between the coal feeder coal outlet and the coal feeder belt. During the operation of the coal feeder belt, due to the certain speed of the belt, the height of the coal feeder belt skirt is not enough, which will cause the coal blocks to fall from both sides of the belt. After optimization (as shown in Figure 2-2), the coal feeder belt edge is raised from 40mm to 60mm. During the falling process, the coal blocks are naturally spread on the upper part of the coal feeder belt. Due to the cooperation of the skirt edge and the coal outlet, all the raw coal on the coal feeder belt is transported to the coal feeder outlet, and the amount of coal blocks falling on both sides of the belt is greatly reduced. This ensures that the coal blocks do not enter the middle layer of the coal feeder belt, and can also solve the problem of inaccurate measurement of the weighing roller caused by the coal blocks entering the weighing device.

Figure 2-1 Before the coal feeder belt was modified Figure 2-2 After the coal feeder belt was modified

1. Solutions to Common Problems
   1) The coal feeder belt was modified: a high-strength, wear-resistant, anti-static conveyor belt was used, and the height of the coal feeder skirt was increased from the original 40mm to 60mm to reduce the risk of wear and fire accidents, and reduce the risk of coal blocks falling from both sides of the belt.

1. Replaced new belt was performed to ensure no coal blocking and minimize the inaccurate data of coal flow. Increase the side skirt wall of belt from 40mm to 60m. This adjustment addressed the issue of inaccurate coal flow and coal blocking.
