OPTIMIZATION OF THE PROTECTION INTERLOCKING FUNCTION OF A 56 MW UNIT STEAM TURBINE

Wang Zhiliang[1], Feng Hongwei[2], Muhammad Ihsan[2]
PT. DSSP Power Kendari, Indonesia[1,2,3]
Email: wang.jingsong@dsspower.co.id[1], feng.hongwei@dsspower.co.id[2], muhammad.ihsan@dsspower.co.id[3]

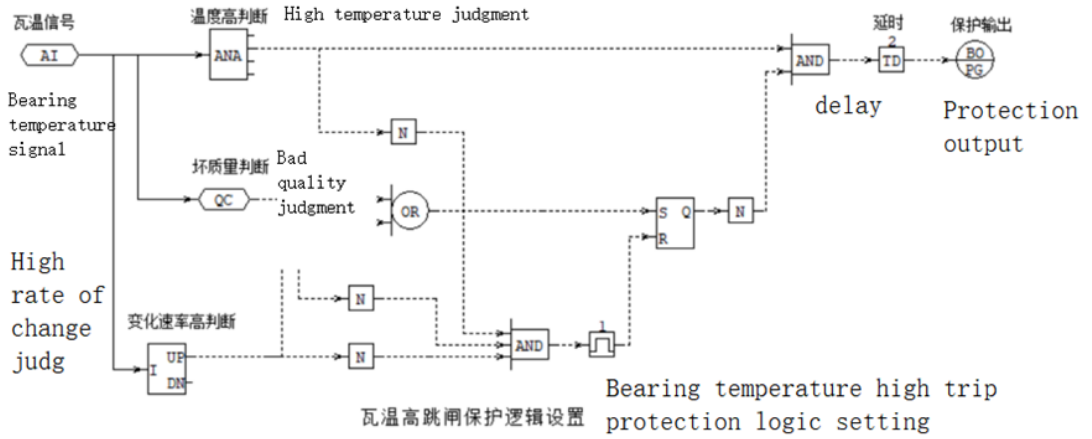
Figure 1. Logic Diagram Turbine Generator Bearing High Temperature Trip

The steam turbine of Kendari Power Generation Company has 4 bearings, each bearing has a thermal resistor for measuring bearing temperature. There are 8 bearing temperature elements for the working face thrust bearing and 2 bearing temperature elements for the non-working face bearing. All of the above temperatures are tripping steam turbines when any point is higher than 100 degrees, single point protection and no rate judgment.

Because the feasibility of adding temperature measurement points is very low, in order to eliminate refusal to operate and reduce false operation, the temperature protection increases the rate and delay. According to relevant regulations and the practical experience of Datang Group's brother power plants, the rate of the thermal resistance of the turbine bearing is set to greater than 5 degrees Celsius/second to shield the protection output, and the delay is set to 2 seconds. Therefore, the final protection setting is: when the temperature of the turbine support bearing is higher than 100 degrees Celsius and the rate of change is less than 5 degrees Celsius/second, the delay

is 2 seconds to adjust the trip; when the temperature of the support bearing is higher than 100 degrees Celsius and the rate of change is less than 5 degrees Celsius/second, the delay is 2 seconds to trip, both of which are single-point protection.

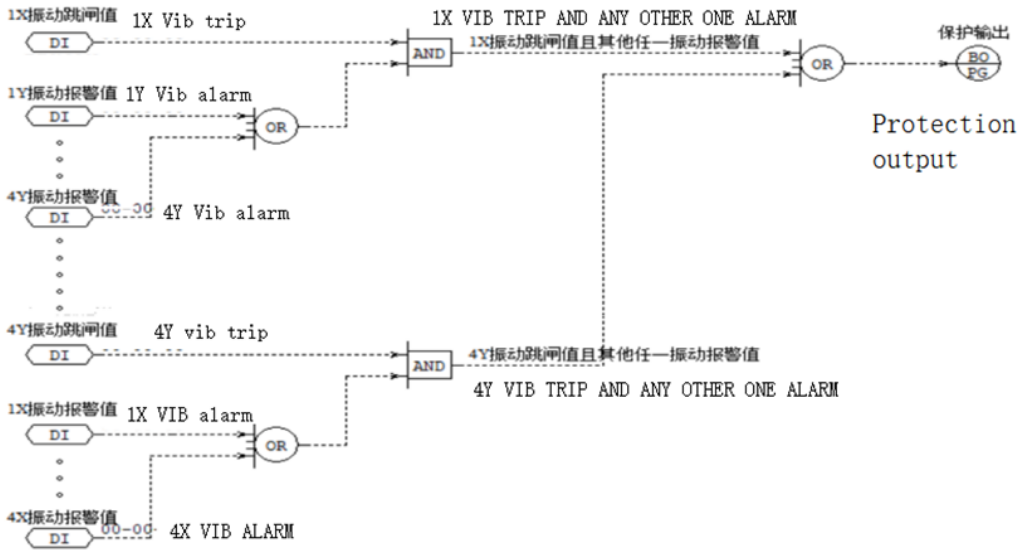
Figure 4. Logic Diagram Vibration Alarm & Trip

The steam turbine of Kendari Power Generation Company has a total of 4 bearings, each of which has 2 shaft vibration measurement points. The original protection method was to trip the steam turbine if any vibration signal reached the tripping value, which did not meet the group company's configuration requirements for vibration protection.

Kendari Power Generation Company has made the following optimization: any vibration higher than the second value (trip value) and any other vibration higher than the first value (alarm value) will trip the turbine.

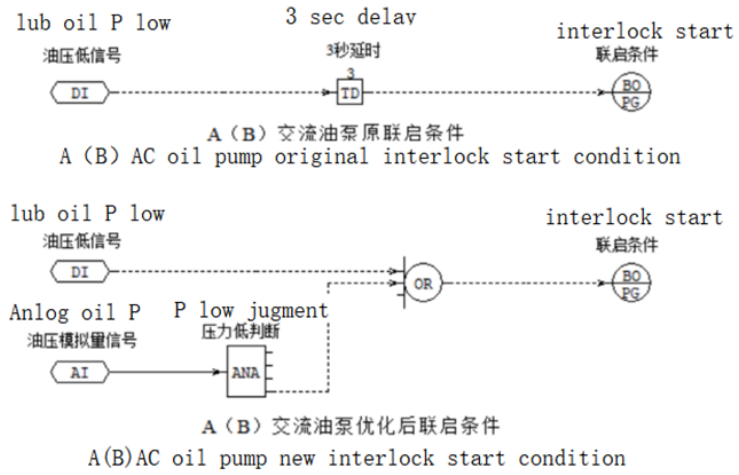
Figure 5. Modification Logic Diagram for Interlocking AC Oil Pump

a. The original logic of joint start of AC oil pump of turbine A (B) is as follows:

1) When the lubricating oil pressure is low (pressure switch), the oil pump will be started after a delay of 3 seconds.

1) Cancel the delay condition of 3 seconds to start the oil pump when the lubricating oil pressure is low (pressure switch), and change it to a delay-free start;
2) Increase the low lubricating oil pressure (analog value) and start the oil pump.

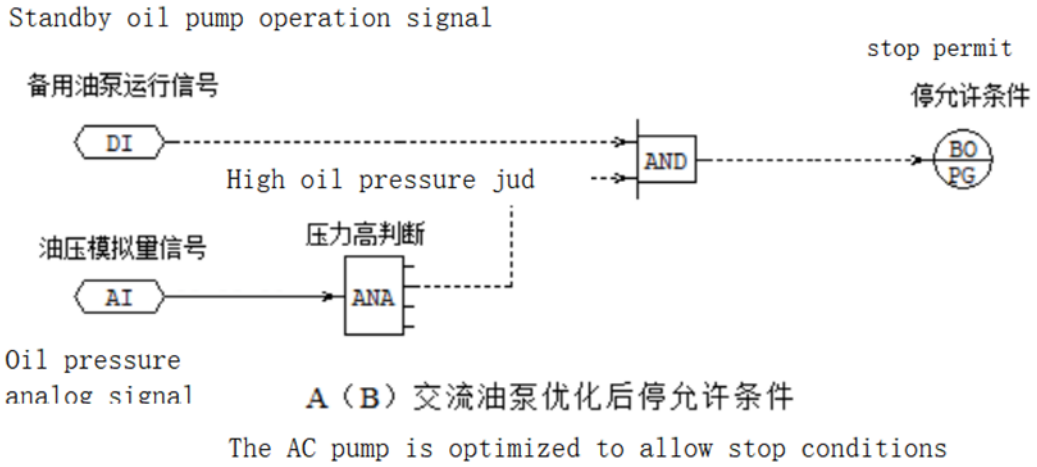
Figure 6. Logic Diagram AC Lube Pump Stop Permission

b. The original logic of the AC oil pump stop permission of turbine A (B) has no locking conditions:

The stop permission condition adds the condition that the standby AC oil pump has been started and the oil pressure is normal.

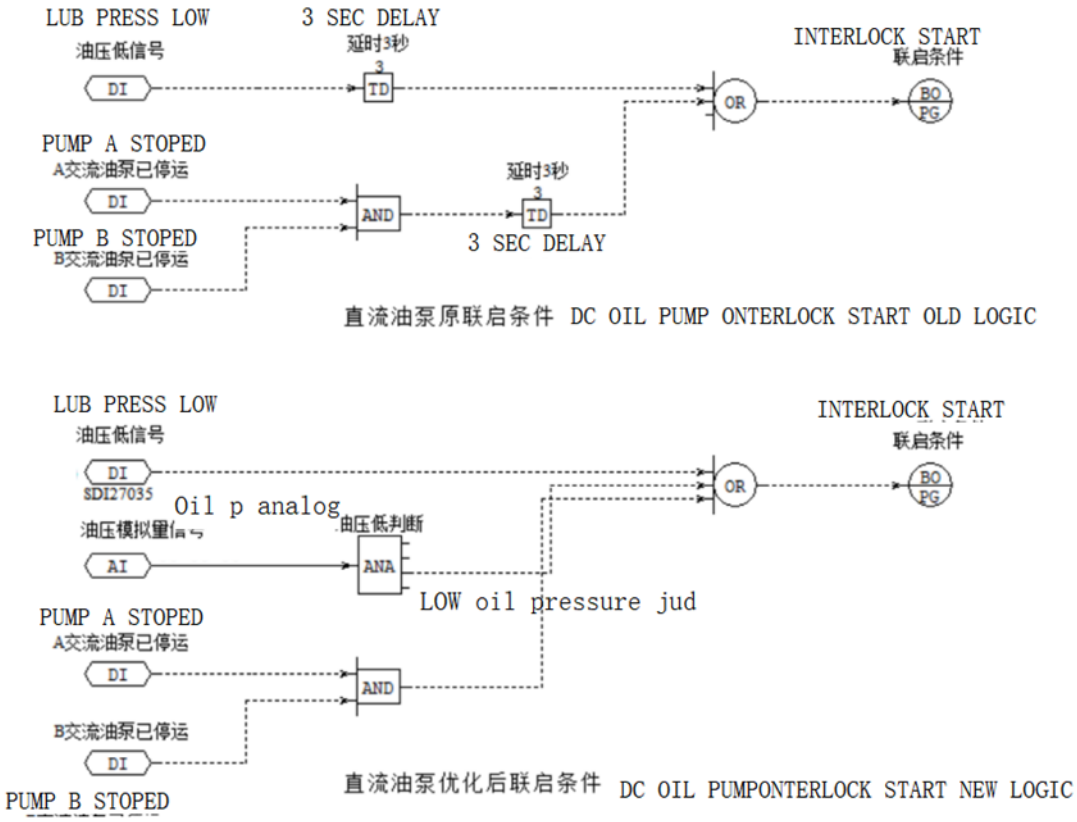
Figure 7. Diagram Logic Modification DC Lube Oil Pump

c. The original logic of turbine DC oil pump joint start is as follows:

1) When the lubricating oil pressure is low (pressure switch), the oil pump will be started after a delay of 3 seconds;
2) Stop both AC oil pumps and restart them after a delay of 3 seconds.

1) Cancel the 3-second delay of the oil pump when the lubricating oil pressure is low (pressure switch) and change it to a delay-free start;
2) Increase the lubricating oil pressure (analog value) and start the oil pump;
3) Both AC oil pumps are stopped, the 3-second delay condition is cancelled, and they are started directly in conjunction with each other.
